Manhole Inspection Summary

Manhole # S31SS_045MH

Insp Date: **5/1/07 12:39 PM**

Location Address: **2800 MILES AVE**

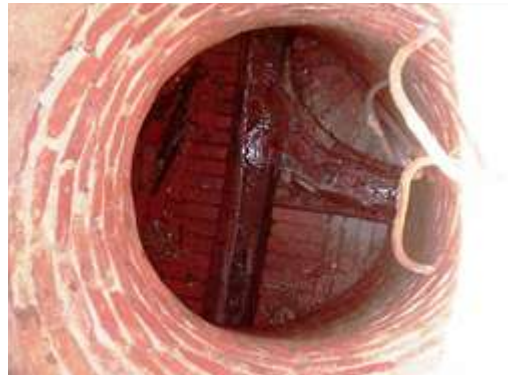
Top View

Steps Count: **3** Missing: **0** ☒ **Corroded**

Surcharge ☒ **Evidence Of Surcharge** Depth: **1** (ft.) ☐ Active Surcharge Present

Corroded steps. Evidence of surcharge - Bench debris.

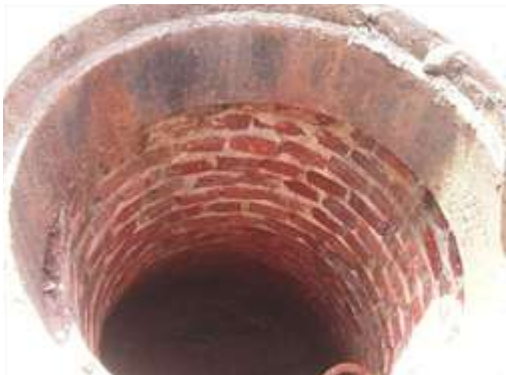
Defect

Frame Offset: **2** (in.) Condition: ☐ Sound ☐ Cracked ☒ **Leaks**

Condition: ☐ Sound ☐ Cracked ☐ Root Intrusion ☐ Loose Brick ☒ **Deteriorated**

Infiltration: ☐ None ☒ **Joint** ☐ Cracks ☒ **Mortar** ☐ Roots ☐ Wall

Frame leaks. Frame offset. Adjustment deterioration and infiltration.

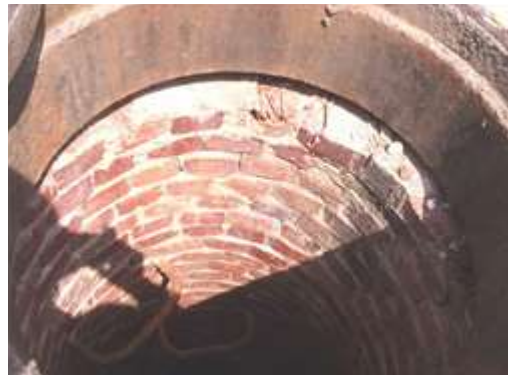
Defect

Frame leaks. Frame offset. Adjustment deterioration and infiltration - other side.

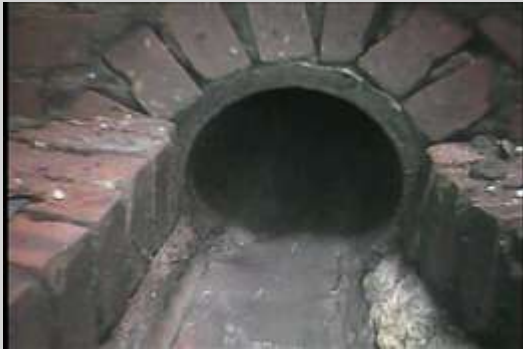
8 in. Circular Gravity Sewer Pipe Out @ 12 O'Clock

Condition: ☐ Sound ☐ Cracked ☐ Root Intrusion ☒ **Deteriorated** ☐ Leaks ☐ Debris

Channel deterioration.

Infiltration: **Evidence** Pipe Seal Cond: **Unknown**

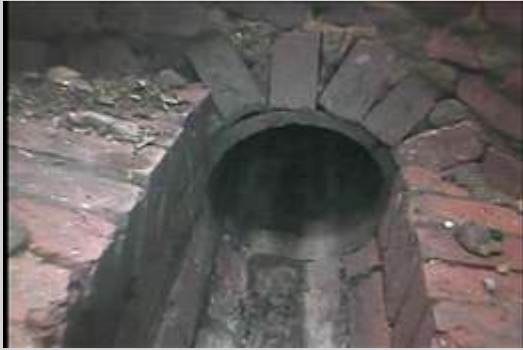
8 in. Circular Gravity Sewer

Condition: ☐ Sound ☐ Cracked ☐ Root Intrusion ☐ Loose Brick ☒ **Deteriorated**

Infiltration: ☐ None ☐ Joint ☐ Cracks ☒ **Mortar** ☐ Roots ☐ Wall

Barrel deterioration and infiltration.

Infiltration: **Evidence** Pipe Seal Cond: **Unknown**
